Home Inspection Report

Condo Sample Report , New York, NY 10001

Saturday August 28, 2021

123456

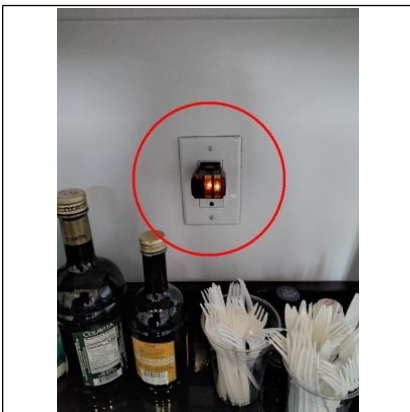
-Recommend installing GFCI receptacles in the kitchen area, potential safety hazard.

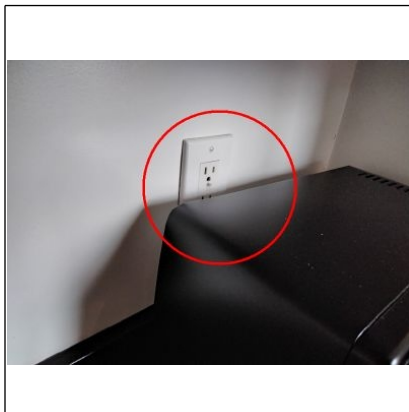
-Recommend installing GFCI receptacles in the kitchen area, potential safety hazard.

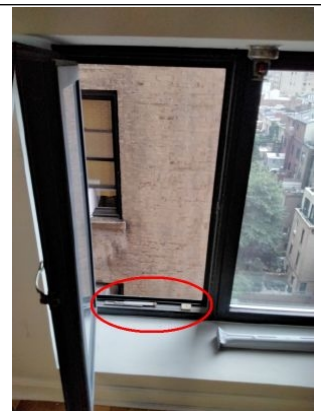
-Evidence of multiple damaged and missing window stays found throughout the unit, recommend licensed professional to evaluate and repair. Potential safety hazard.

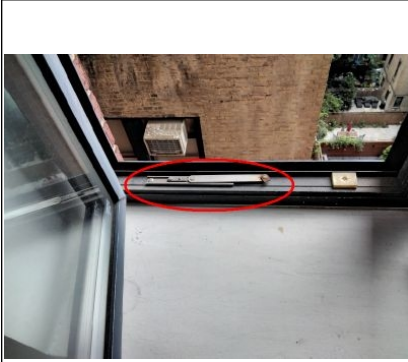
-Evidence of multiple damaged and missing window stays found throughout the unit, recommend licensed professional to evaluate and repair. Potential safety hazard.

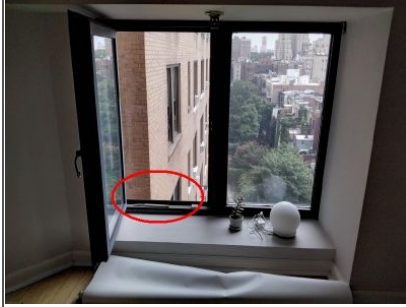
-Evidence of multiple damaged and missing window stays found throughout the unit, recommend licensed professional to evaluate and repair. Potential safety hazard.

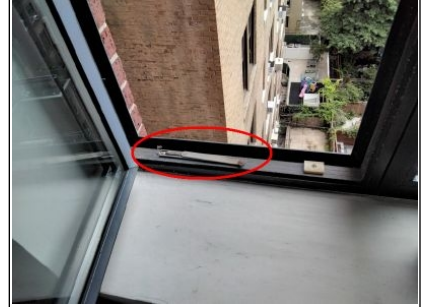
-Evidence of multiple damaged and missing window stays found throughout the unit, recommend licensed professional to evaluate and repair. Potential safety hazard.

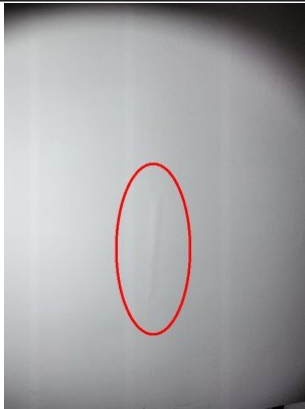
-Evidence of multiple settlement cracks found on the upper level bedroom ceiling and walls, recommend licensed professional to evaluate and repair.

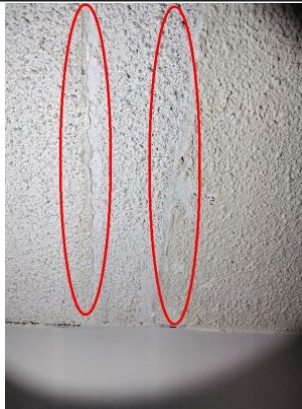
-Evidence of multiple settlement cracks found on the upper level bedroom ceiling and walls, recommend licensed professional to evaluate and repair.

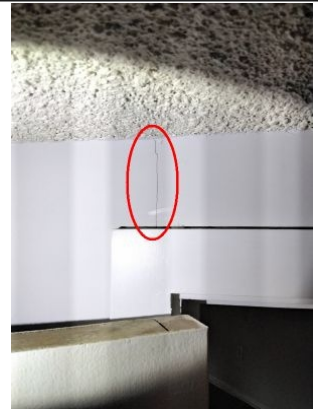
-Evidence of multiple settlement cracks found on the upper level bedroom ceiling and walls, recommend licensed professional to evaluate and repair.

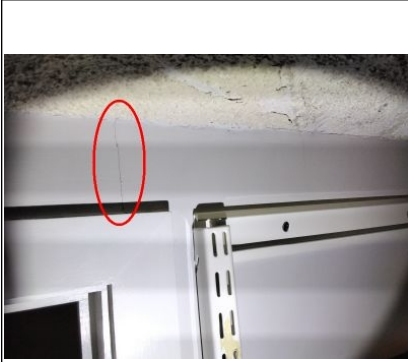
-Evidence of multiple settlement cracks found on the upper level bedroom ceiling and walls, recommend licensed professional to evaluate and repair.

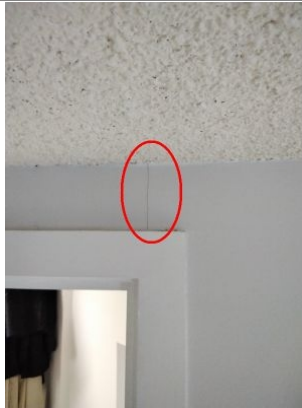
-Evidence of multiple settlement cracks found on the upper level bedroom ceiling and walls, recommend licensed professional to evaluate and repair.

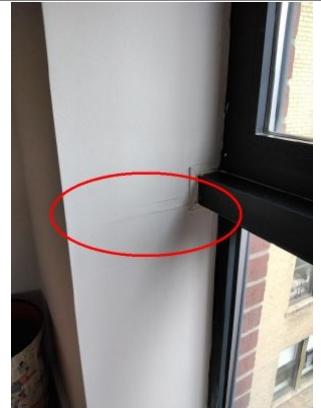
-Evidence of multiple settlement cracks found on the upper level bedroom ceiling and walls, recommend licensed professional to evaluate and repair.

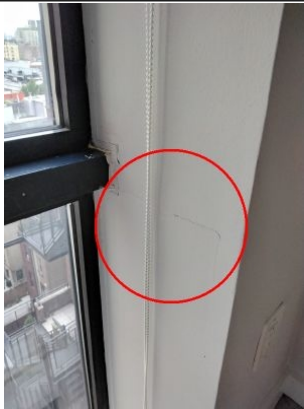
-Evidence of multiple settlement cracks found on the upper level bedroom ceiling and walls, recommend licensed professional to evaluate and repair.

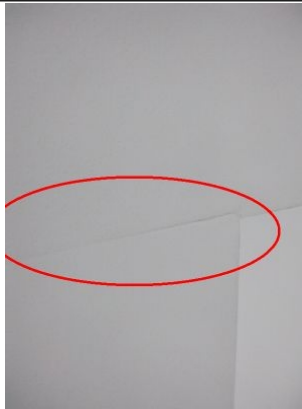
-Evidence of multiple settlement cracks found on the upper level bedroom ceiling and walls, recommend licensed professional to evaluate and repair.

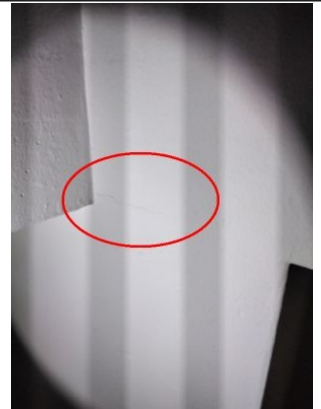
-Evidence of multiple settlement cracks found on the upper level bedroom ceiling and walls, recommend licensed professional to evaluate and repair.

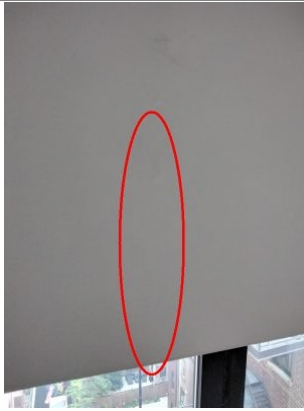
-Evidence of multiple settlement cracks found on the upper level bedroom ceiling and walls, recommend licensed professional to evaluate and repair.

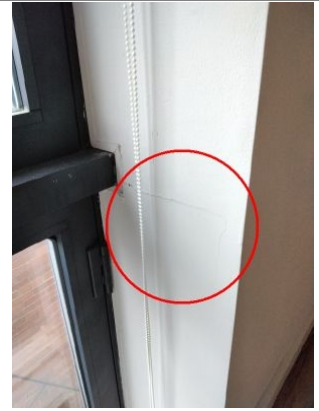
-Evidence of multiple settlement cracks found on the upper level bedroom ceiling and walls, recommend licensed professional to evaluate and repair.

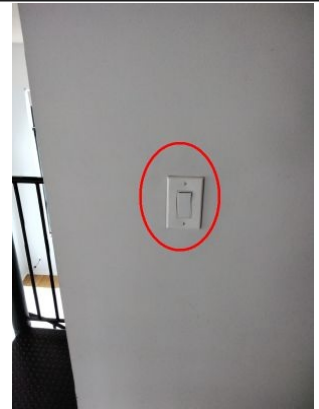
-Evidence of inoperable light switches found in the upper level bedroom area, recommend licensed electrician to evaluate and repair. Potential safety hazard.

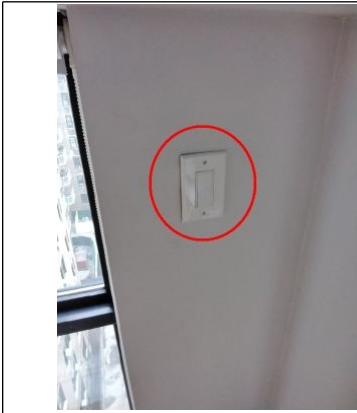
-Evidence of inoperable light switches found in the upper level bedroom area, recommend licensed electrician to evaluate and repair. Potential safety hazard.

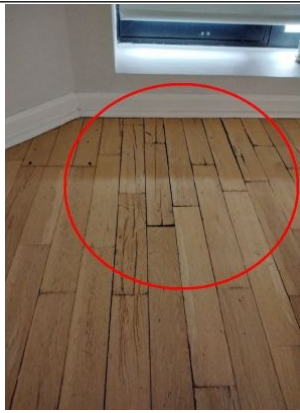
-Evidence of loose and damaged flooring found in the upper level bedroom area, recommend licensed professional to evaluate and repair.

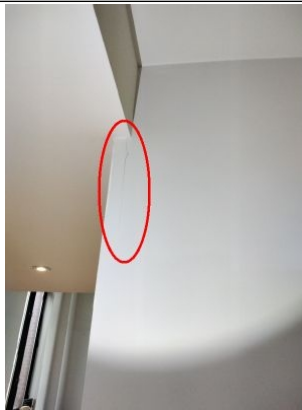
-Evidence of multiple settlement cracks found on the lower level ceiling and walls, recommend licensed professional to evaluate and repair.

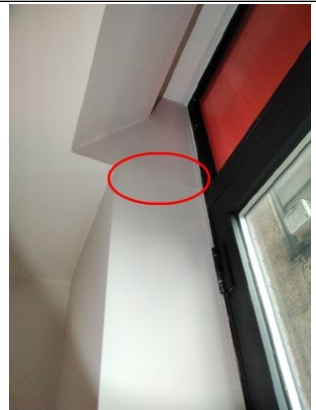
-Evidence of multiple settlement cracks found on the lower level ceiling and walls, recommend licensed professional to evaluate and repair.

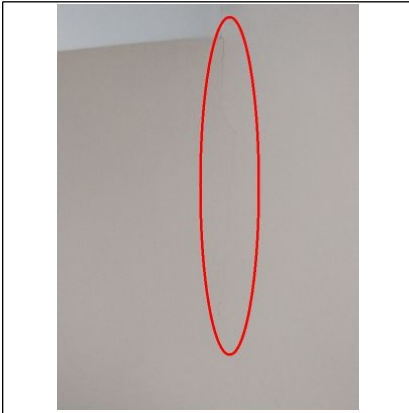
-Evidence of multiple settlement cracks found on the lower level ceiling and walls, recommend licensed professional to evaluate and repair.

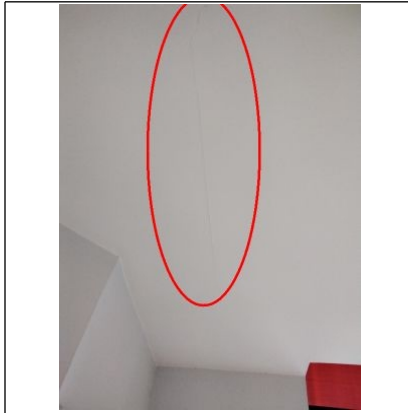
-Evidence of multiple settlement cracks found on the lower level ceiling and walls, recommend licensed professional to evaluate and repair.

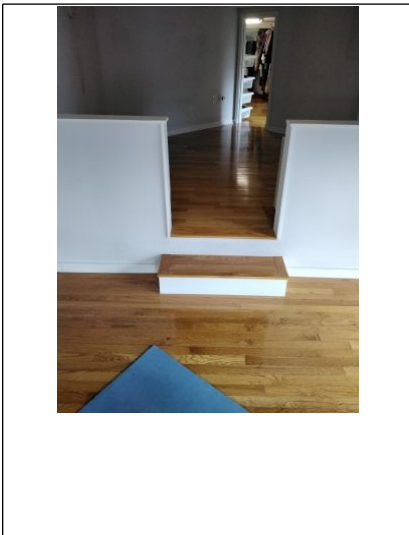
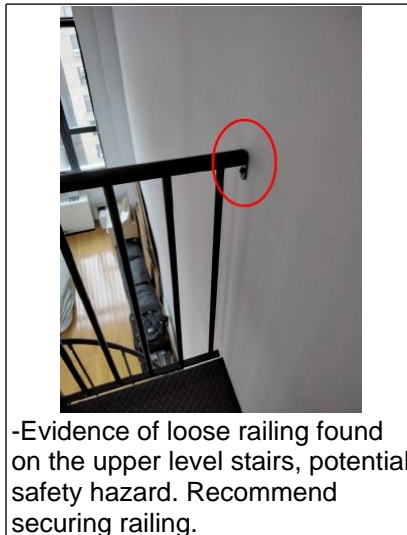
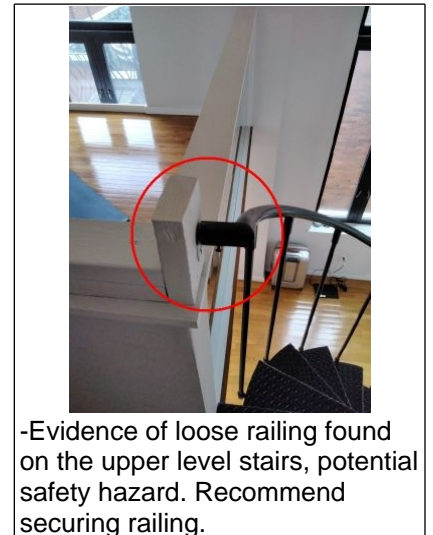
Comments -Evidence of loose railing found on the upper level stairs, potential safety hazard. Recommend securing railing.

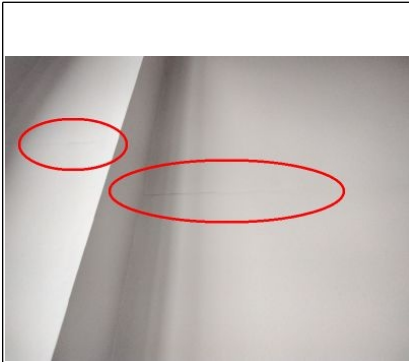
-Evidence of multiple settlement cracks and peeling paint found on the lower level living room walls, recommend licensed professional to evaluate and repair.

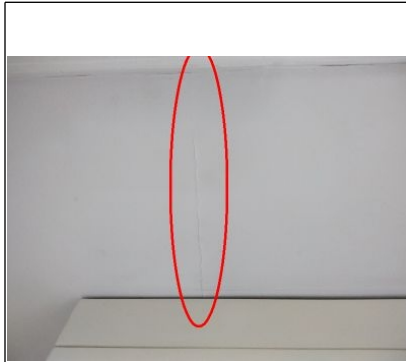
-Evidence of multiple settlement cracks and peeling paint found on the lower level living room walls, recommend licensed professional to evaluate and repair.

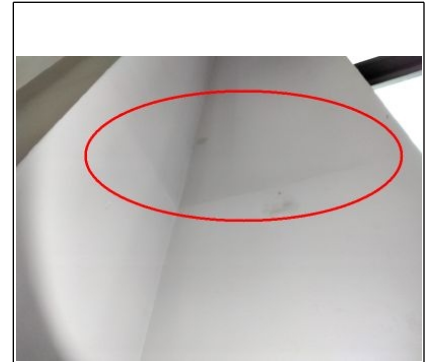
-Evidence of multiple settlement cracks and peeling paint found on the lower level living room walls, recommend licensed professional to evaluate and repair.

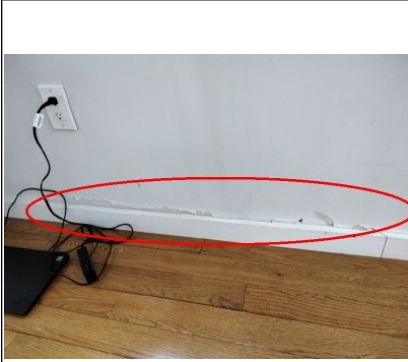
-Evidence of multiple settlement cracks and peeling paint found on the lower level living room walls, recommend licensed professional to evaluate and repair.

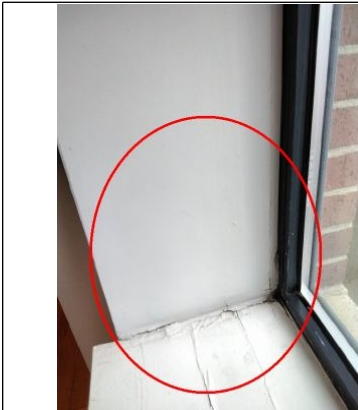
-Evidence of excessive moisture found on the dining room walls, recommend licensed professional to evaluate and repair.

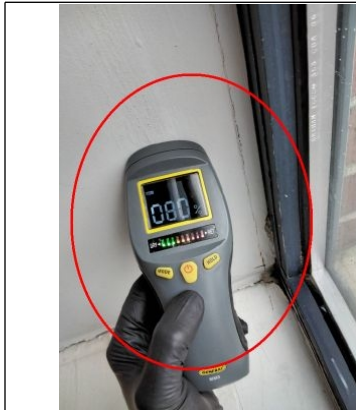
-Evidence of excessive moisture found on the dining room walls, recommend licensed professional to evaluate and repair.

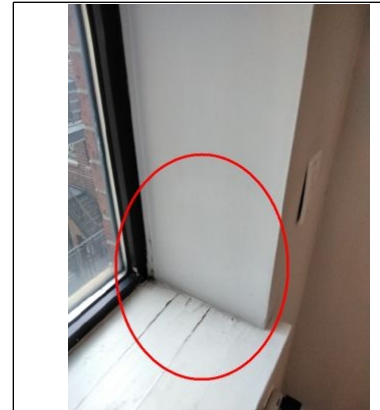
-Evidence of excessive moisture found on the dining room walls, recommend licensed professional to evaluate and repair.

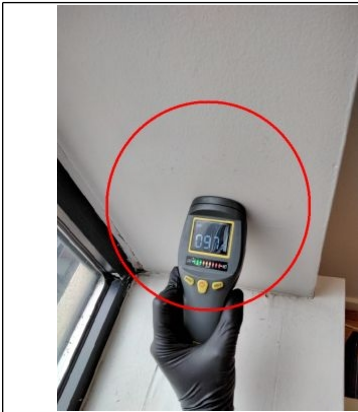
-Evidence of excessive moisture found on the dining room walls, recommend licensed professional to evaluate and repair.

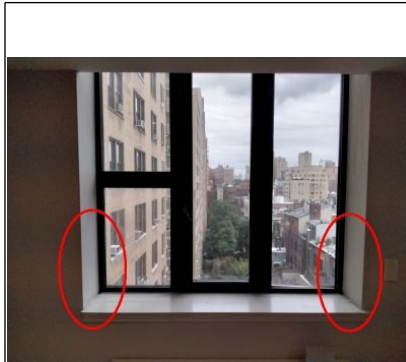
-Evidence of excessive moisture found on the dining room walls, recommend licensed professional to evaluate and repair.
