Home Inspection Report

Condo Sample Report , New York, NY 10001

Saturday August 28, 2021

123456

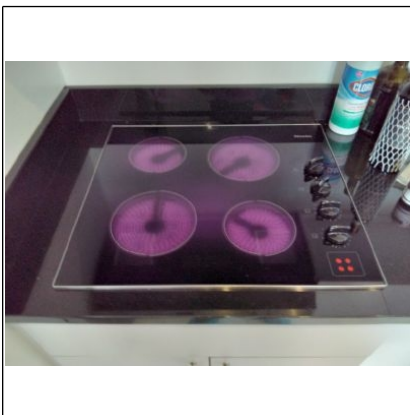
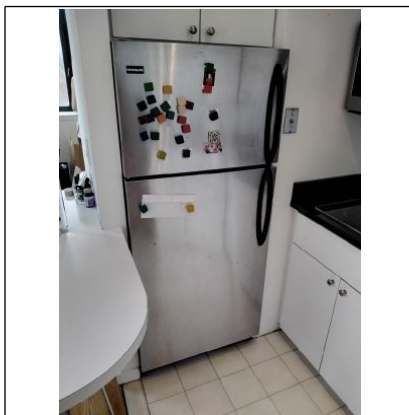
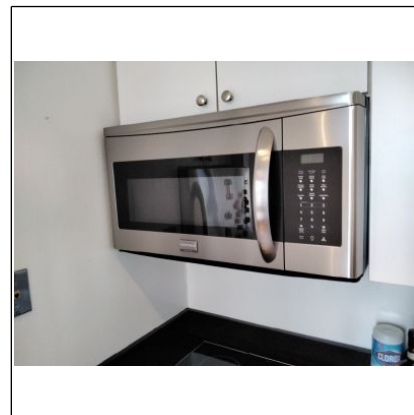
Comments -Recommend installing GFCI receptacles in the kitchen area, potential safety hazard.

-Recommend installing GFCI receptacles in the kitchen area, potential safety hazard.

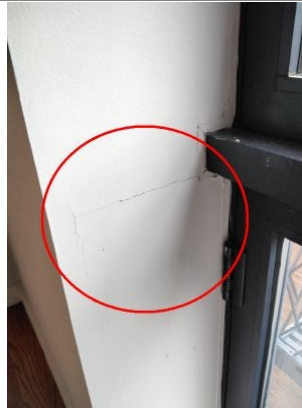
-Evidence of multiple settlement cracks found on the upper level bedroom ceiling and walls, recommend licensed professional to evaluate and repair.

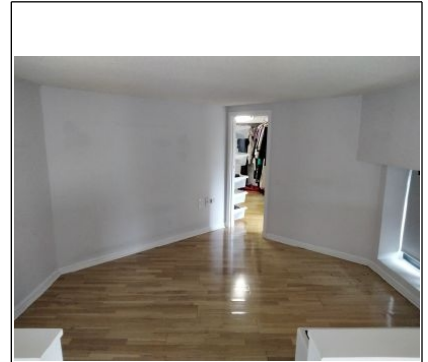
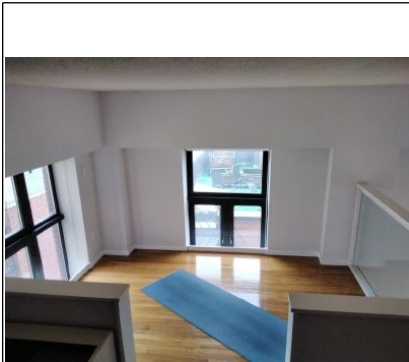
-Evidence of loose and damaged flooring found in the upper level bedroom area, recommend licensed professional to evaluate and repair.

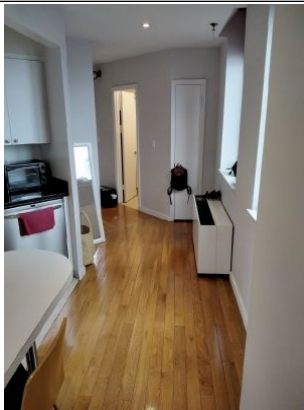
Comments -Evidence of multiple settlement cracks found on the lower level ceiling and walls, recommend licensed professional to evaluate and repair.

-Evidence of multiple settlement cracks found on the lower level ceiling and walls, recommend licensed professional to evaluate and repair.

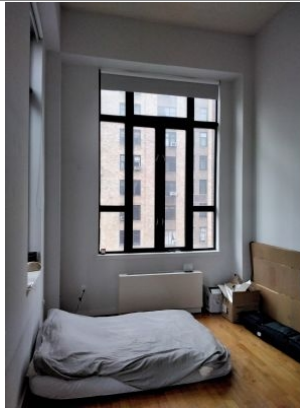
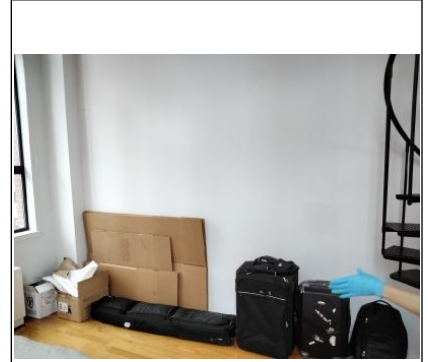
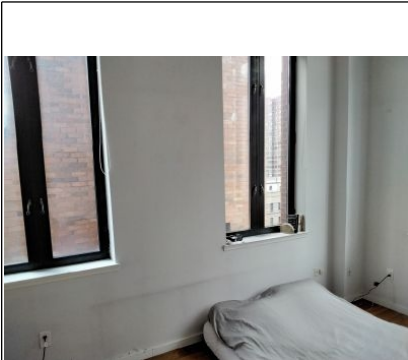
-Evidence of multiple settlement cracks and peeling paint found on the lower level living room walls, recommend licensed professional to evaluate and repair.

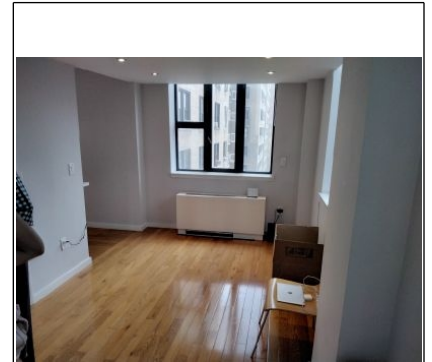
-Evidence of excessive moisture found on the dining room walls, recommend licensed professional to evaluate and repair.
